Manhole Inspection Summary

Manhole # S13QQ1025MH

Insp Date: **11/1/06 1:53 PM**

Location Address: **2701 OAKLEY AVE**

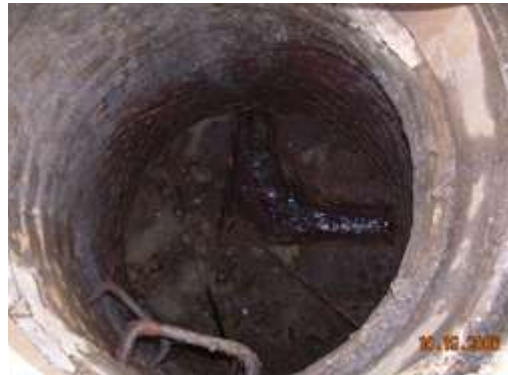
Top View

Corroded steps. Bench debris.

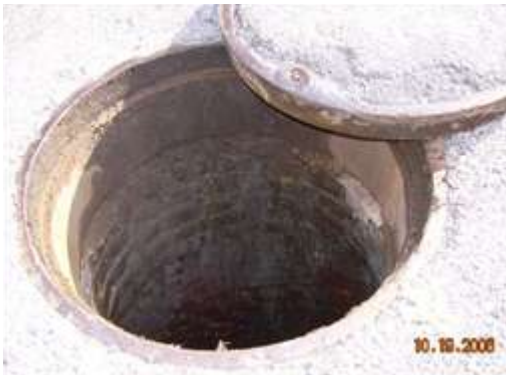
Defect

Frame Offset: **0** (in.) Condition: ☐ Sound ☐ Cracked ☒ **Leaks**

Chimney / Frame Adjustment ☒ Exists Material: **Brick** ☐ Parged Height: **4** (in.)
Condition: ☐ Sound ☐ Cracked ☐ Root Intrusion ☐ Loose Brick ☒ **Deteriorated**
Infiltration: ☐ None ☒ **Joint** ☐ Cracks ☒ **Mortar** ☐ Roots ☐ Wall

Frame leaks. Adjustment deterioration and infiltration.

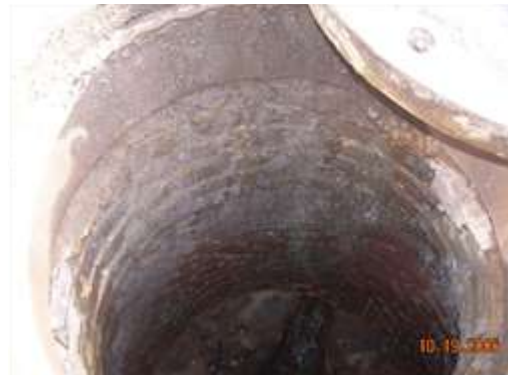
Defect

Frame leaks. Adjustment deterioration and infiltration.

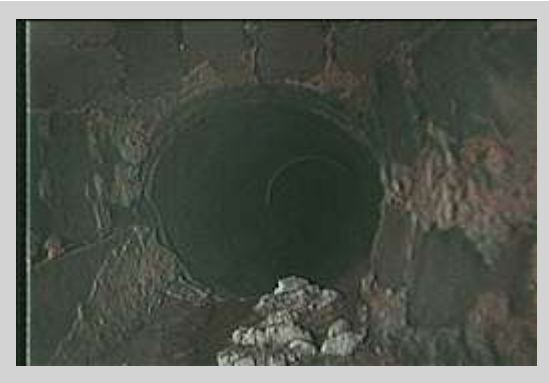
8 in. Circular Gravity Sewer Pipe Out @ 12 O'Clock

Deposits: ☐ None ☐ Mud ☐ Sludge ☒ Debris ☒ Grease

Infiltration: **Evidence** Pipe Seal Cond: **Unknown**

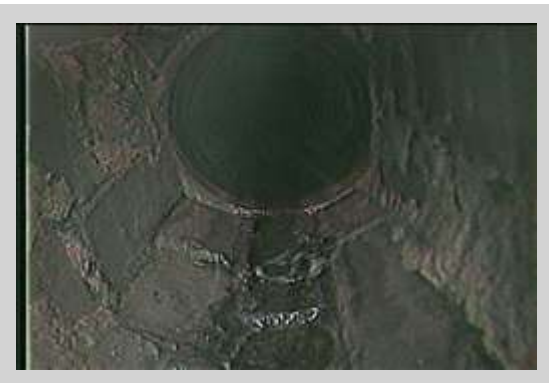
8 in. Circular Gravity Sewer Pipe In @ 3 O'Clock

Channel Material: **Brick** ☐ Parged ☐ Debris (not Condition related)
Channel Exposure: **Fully Open** Junc Dist: **0** nearest .5 ft. Azimuth:
Condition: ☐ Sound ☐ Cracked ☒ **Root Intrusion** ☒ **Deteriorated** ☐ Leaks ☐ Debris

Channel deterioration and root intrusion.

Infiltration: **None** Pipe Seal Cond: **Cracked**
